**DEPARTMENT OF TRANSPORTATION**

Contract #: 04-0120F4Cty: SF/ALA Rte: 80 PM: 13.2/13.9File #: 69.28**WELDING INSPECTION REPORT****Resident Engineer:** Siegenthaler, Peter**Address:** 333 Burma Road**City:** Oakland, CA 94607**Report No:** WIR-018285**Date Inspected:** 21-Nov-2010**Project Name:** SAS Superstructure**OSM Arrival Time:** 700**Prime Contractor:** American Bridge/Fluor Enterprises, a JV**OSM Departure Time:** 1900**Contractor:** Zhenhua Port Machinery Company, Ltd (ZPMC), Changxing Island **Location:** Shanghai, China**CWI Name:** Zho Zhong Hai**CWI Present:** Yes No**Inspected CWI report:** Yes No N/A**Rod Oven in Use:** Yes No N/A**Electrode to specification:** Yes No N/A**Weld Procedures Followed:** Yes No N/A**Qualified Welders:** Yes No N/A**Verified Joint Fit-up:** Yes No N/A**Approved Drawings:** Yes No N/A**Approved WPS:** Yes No N/A**Delayed / Cancelled:** Yes No N/A**Bridge No:** 34-0006**Component:** OBG COMPONENT**Summary of Items Observed:**

## WELDING INSPECTION REPORT

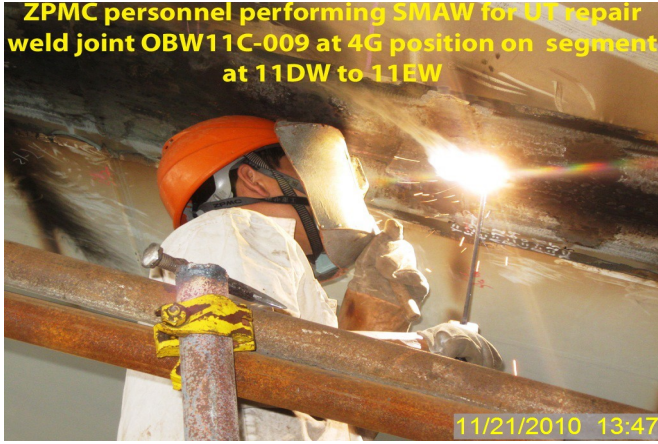
SMAW in the 4G position for the OBG segment 11DW to 11EW, weld No.OBW11C-009.The welder is identified as #040724. ZPMC QC is identified as Mr. Shi Lei. The welding variables recorded by QC appear to comply with WPS-345-SMAW-4G(4F)-FCM-REPAIR-1.The repair report is identified as WR17472.

ZPMC personnel performing SMAW for UT repair  
weld joint OBW11C-009 at 4G position on segment  
at 11DW to 11EW
